ASSESSMENT REPORT

Assessment of fire resistance performance of Speedpanel 4-
hour double skin wall system

Client: Speedpanel Holdings Pty Ltd

Date: 26 March 2019 Revision: R2.0

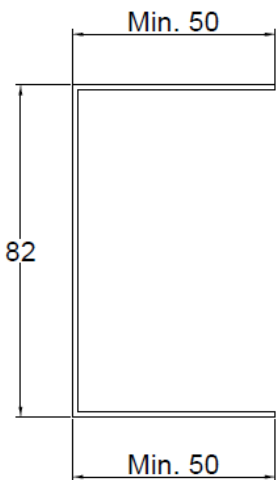
ID	Description	
1	Name	78mm Speedpanel Panel
	Material	285mm wide x 78mm thick Speedpanel panels are made from 0.40mm BMT roll-formed galvanised steel shells seamed together and filled with lightweight aerated concrete.
	Installation	Fitted together (tongue and groove) horizontally. The maximum gap between panel and head C-track is 20mm wide and the maximum gap between panel and side C-track is 10mm wide.
2	Name	C Track
	Material	1.15mm BMT galvanised mild steel
	Specification

<p>Fixed to steel structure with 10 gauge x 30mm long self-drilling screws at 500mm centres and fixed to the Speedpanel panel with 10 gauge x 30mm long self-drilling screws at 250mm centres.</p>
3	Name	J Track
	Material	1.15mm BMT galvanised mild steel
	Specification

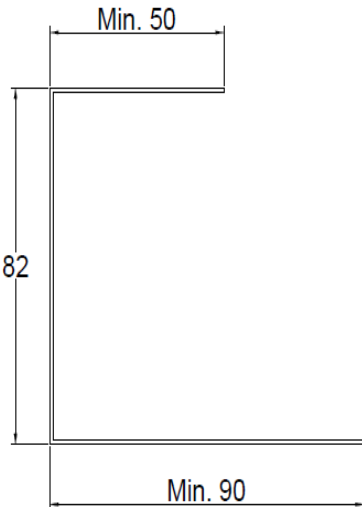
<p>Fixed to steel structure with 10 gauge x 30mm long self-drilling screws at 500mm centres and fixed to the Speedpanel panel with 10 gauge x 30mm long self-drilling screws at 250mm centres.</p>

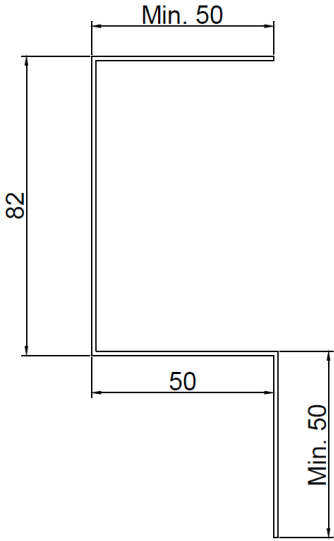
4	Name	P Track
	Material	1.15mm BMT galvanised mild steel

<p>Fixed to steel structure with 10 gauge x 30mm long self-drilling screws at 500mm centres and fixed to the Speedpanel panel with 10 gauge x 30mm long self-drilling screws at 250mm centres.</p>
5	Name	Track fixing to Concrete Construction
	Material	Minimum 5mm mushroom head spikes or metal pin anchors
	Installation	Mechanical fixing of track to surround at maximum 500mm centres and shall be in accordance with project engineer's specification and at least 40mm embedment.
6	Name	Panel to Panel connecting screws
	Material	10G x 16mm self-drilling screws
	Spacing	Fixed into every joint on one face of both Speedpanel layers at 1000mm centres
7	Name	Protection – Fire Grade Plasterboard
	Material	One of 13mm thick fire grade plasterboard strip x 120mm wide for head track One of 13mm thick fire grade plasterboard strip x 160mm wide for side track
	Installation	Fixed on one side of the C-track and the plasterboard strip is fixed to Speedpanel by 6g x 40mm Bugle head, Fine thread, Self-drilling screws in two lines and staggered at 200mm centres.
